**New Croton  
Dam Rehabilitation  
and Normal Pool Raise**

**Croton-on-Hudson  
Village Board of Trustees  
Informational Presentation**

**June 16, 2008**

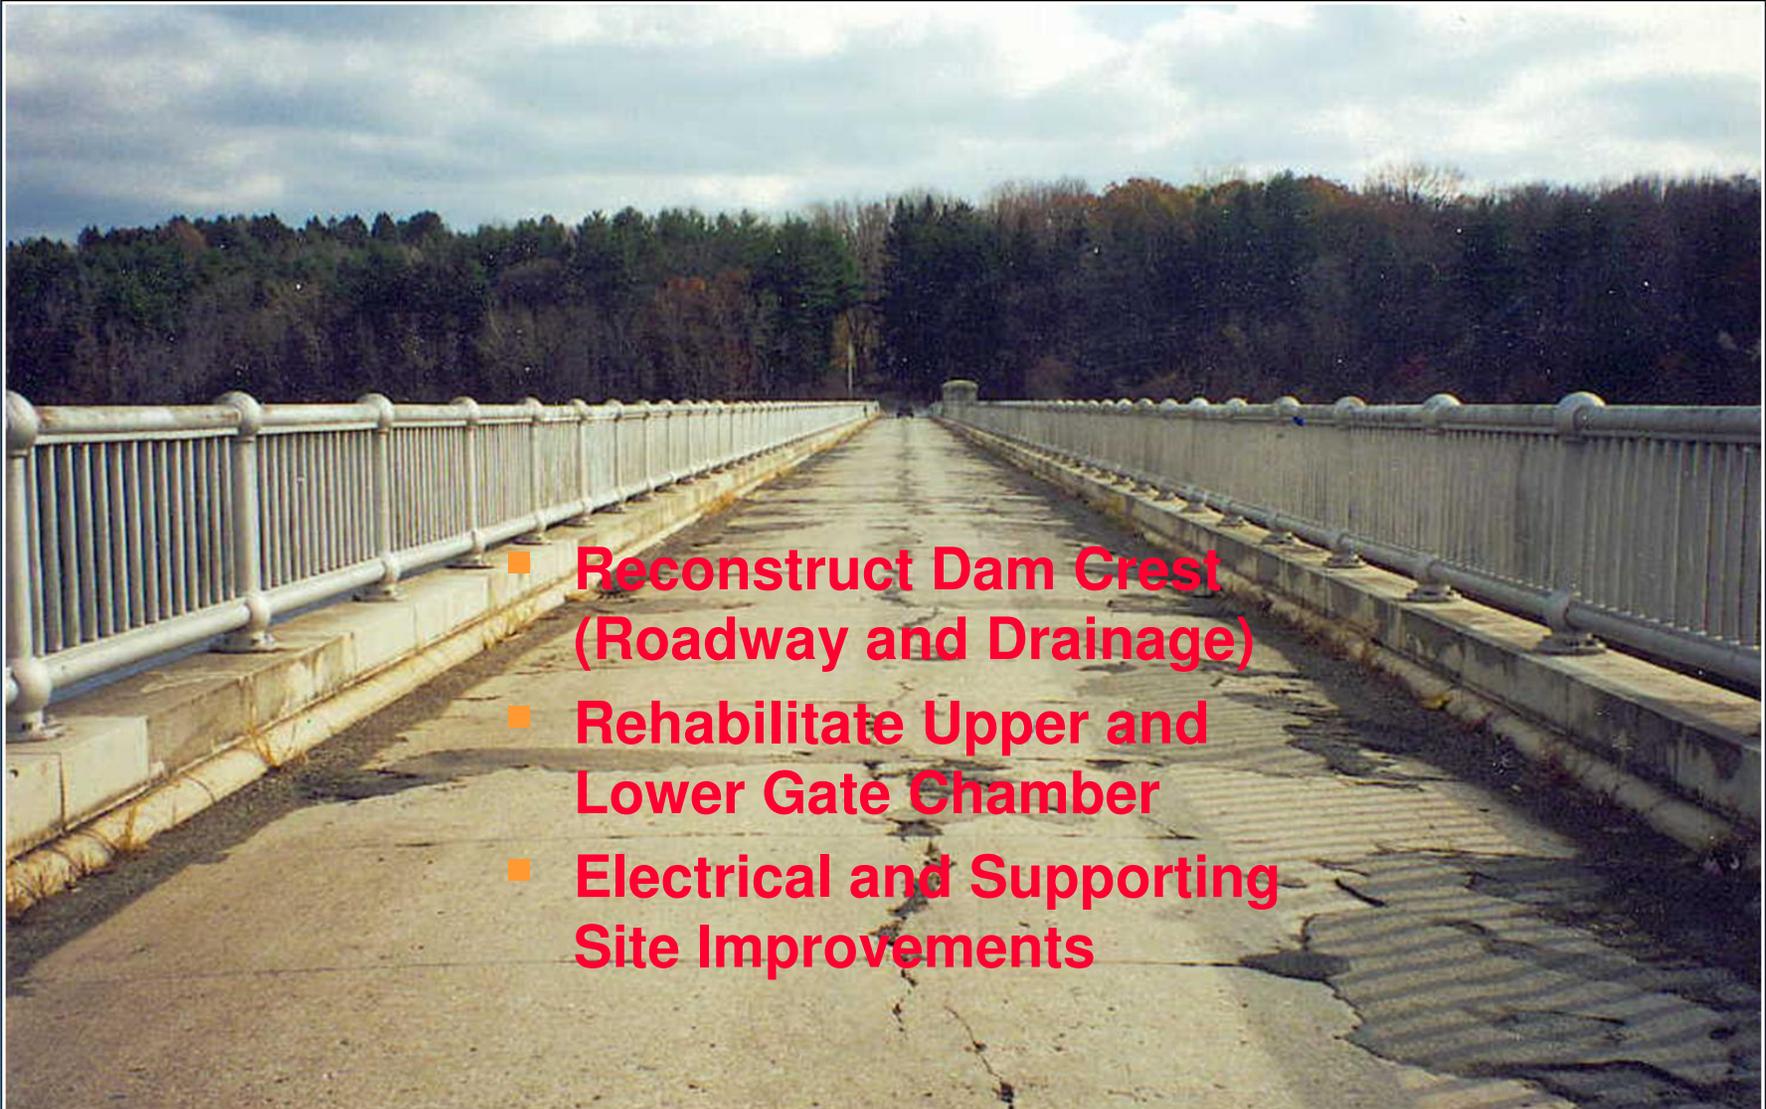
# Dam Rehabilitation

- **Reconstruct Dam Crest (Roadway and Drainage)**
- **Rehabilitate Upper and Lower Gate Chamber**
- **Electrical and Supporting Site Improvements**

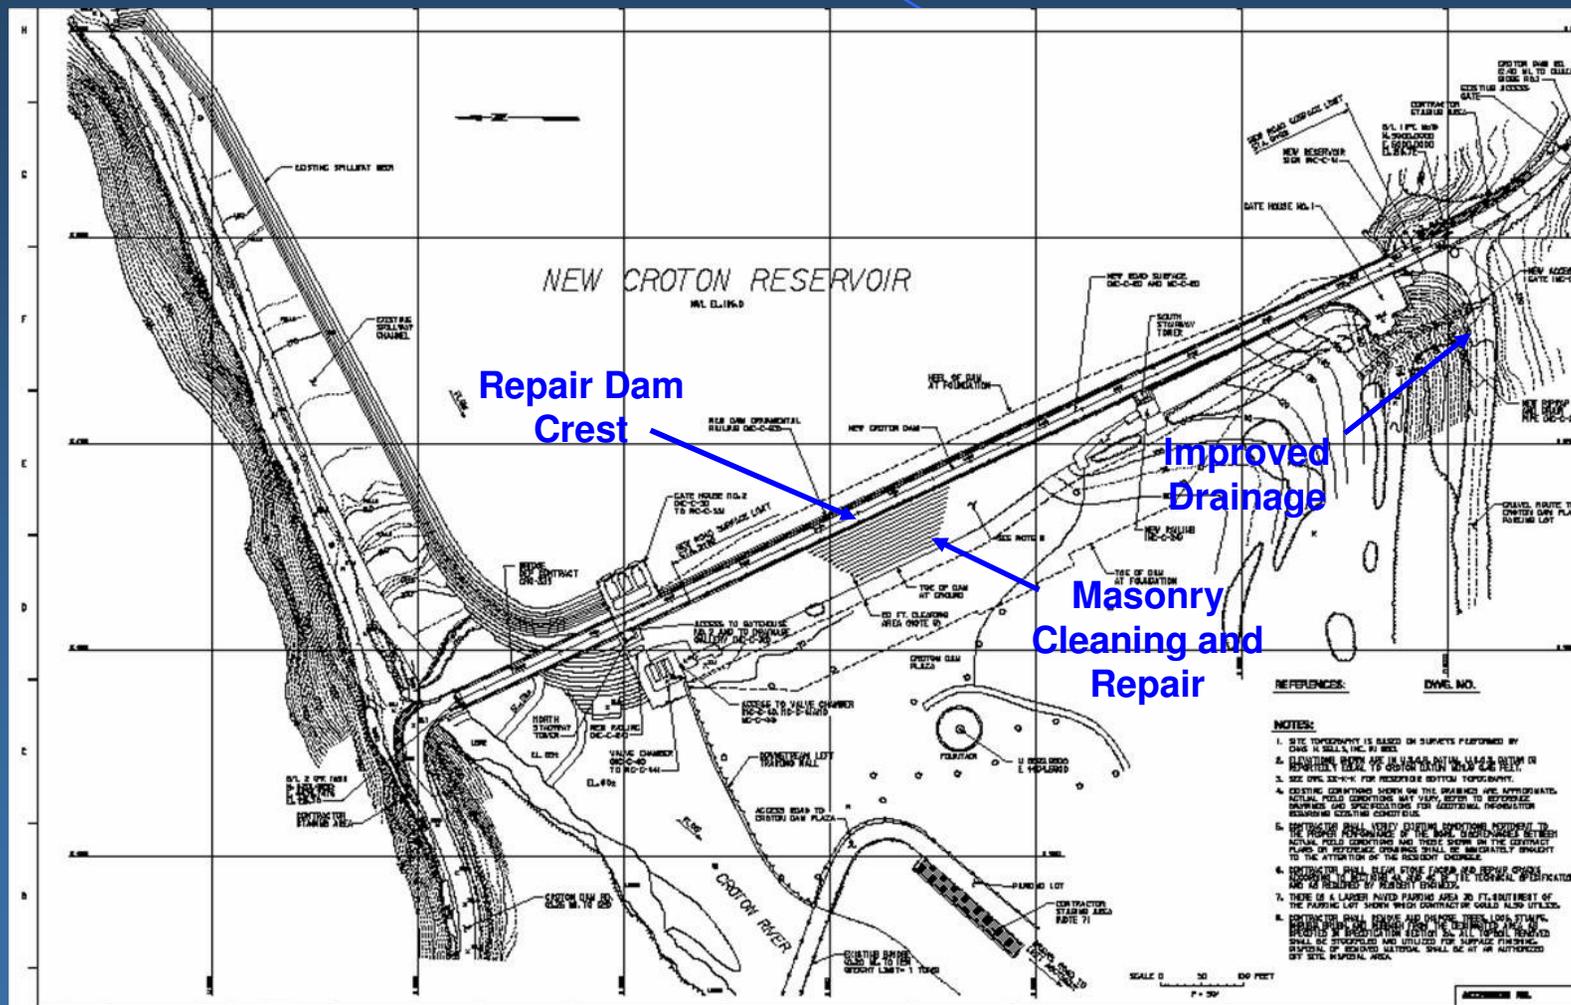
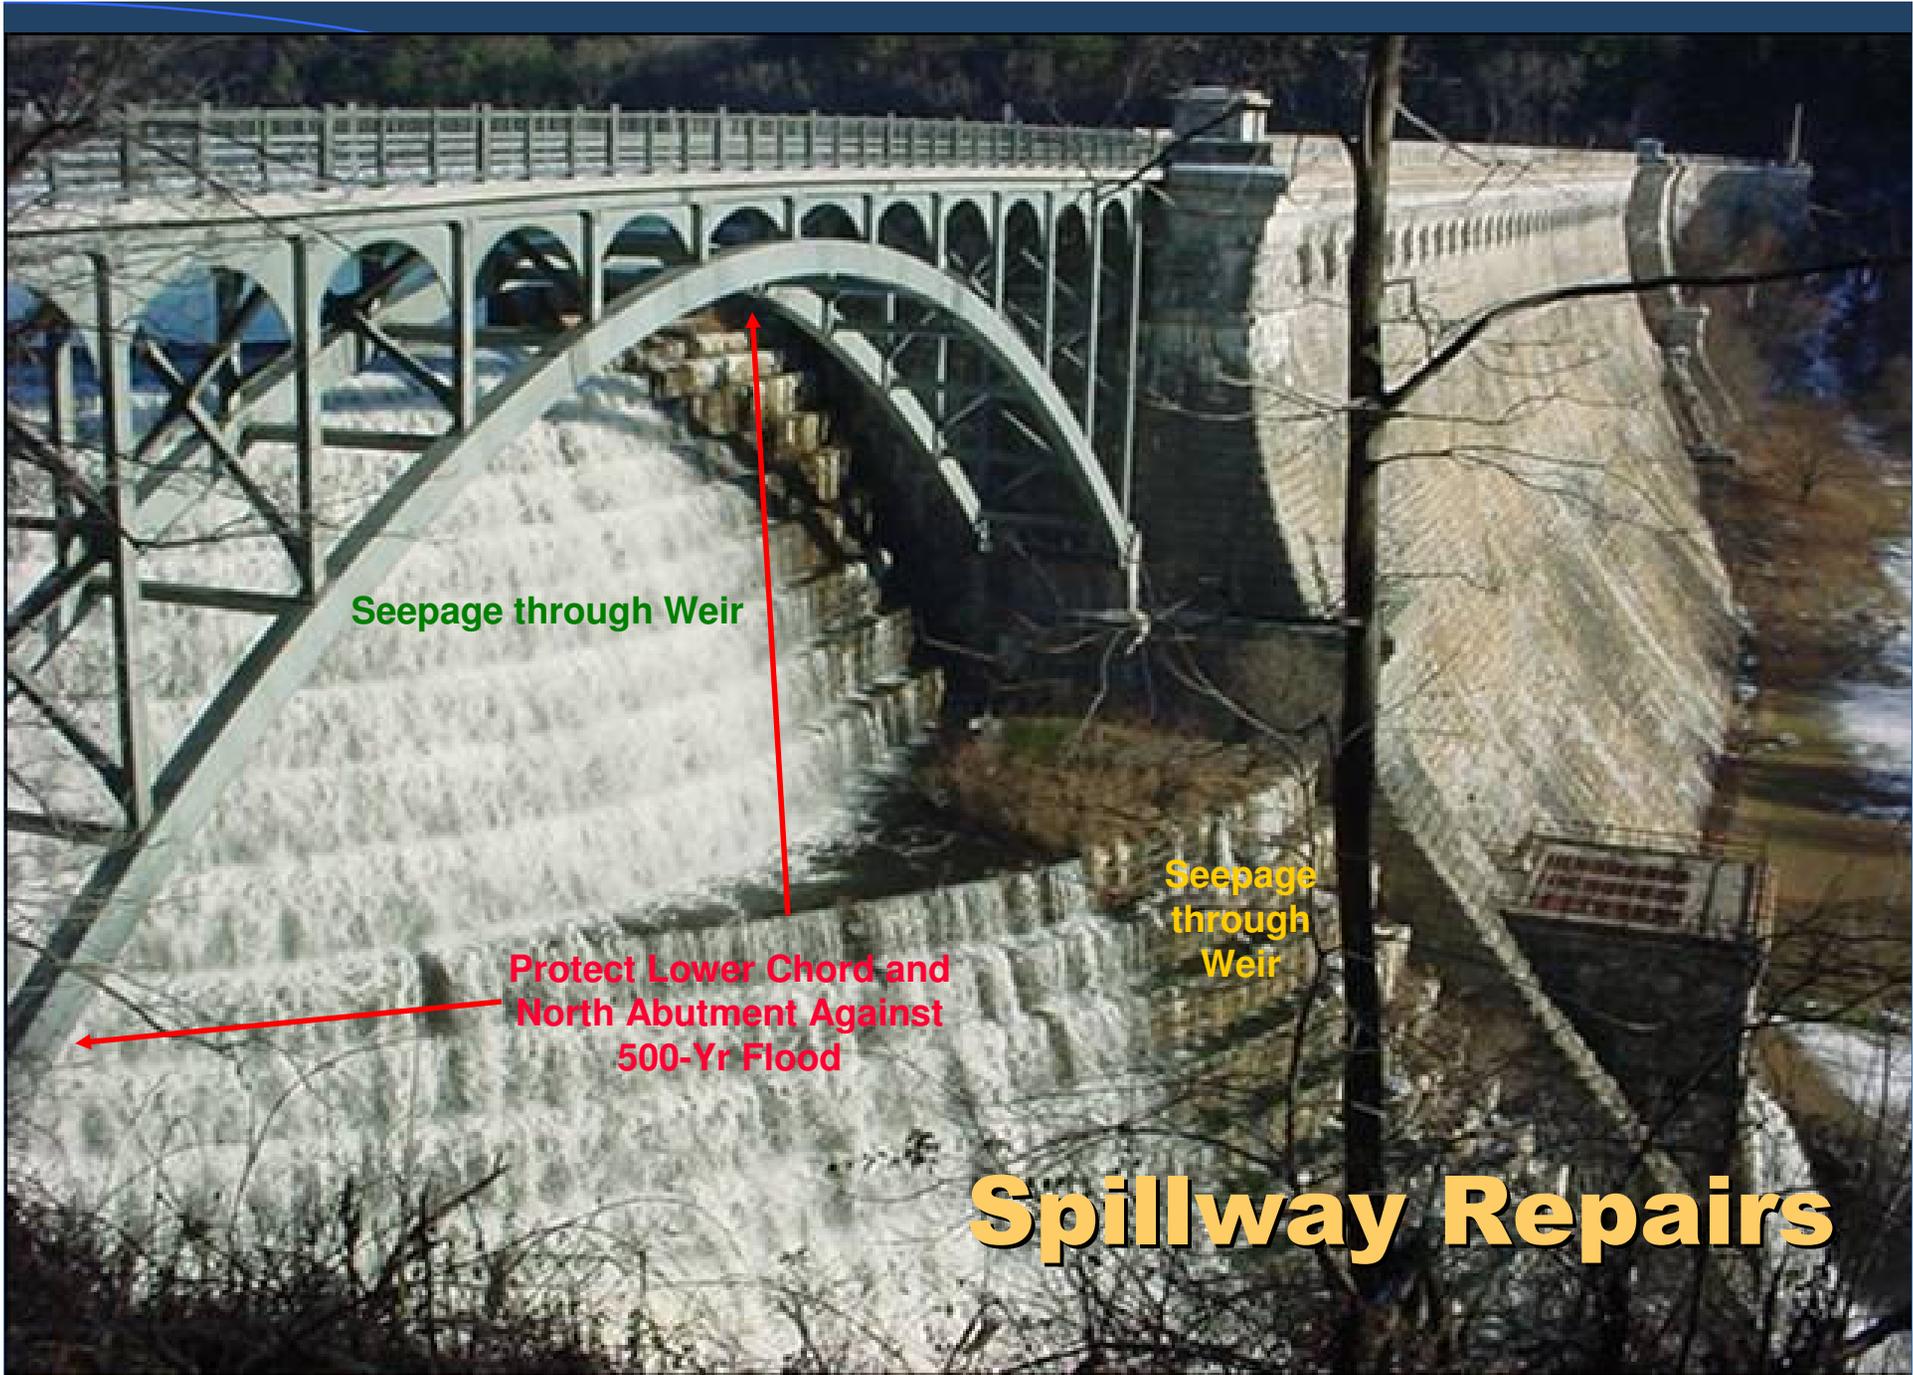
# Dam Crest and Other Related Work

Seepage through Weir

Protect Lower Chord and  
North Abutment Against  
500-Yr Flood

Seepage  
through  
Weir

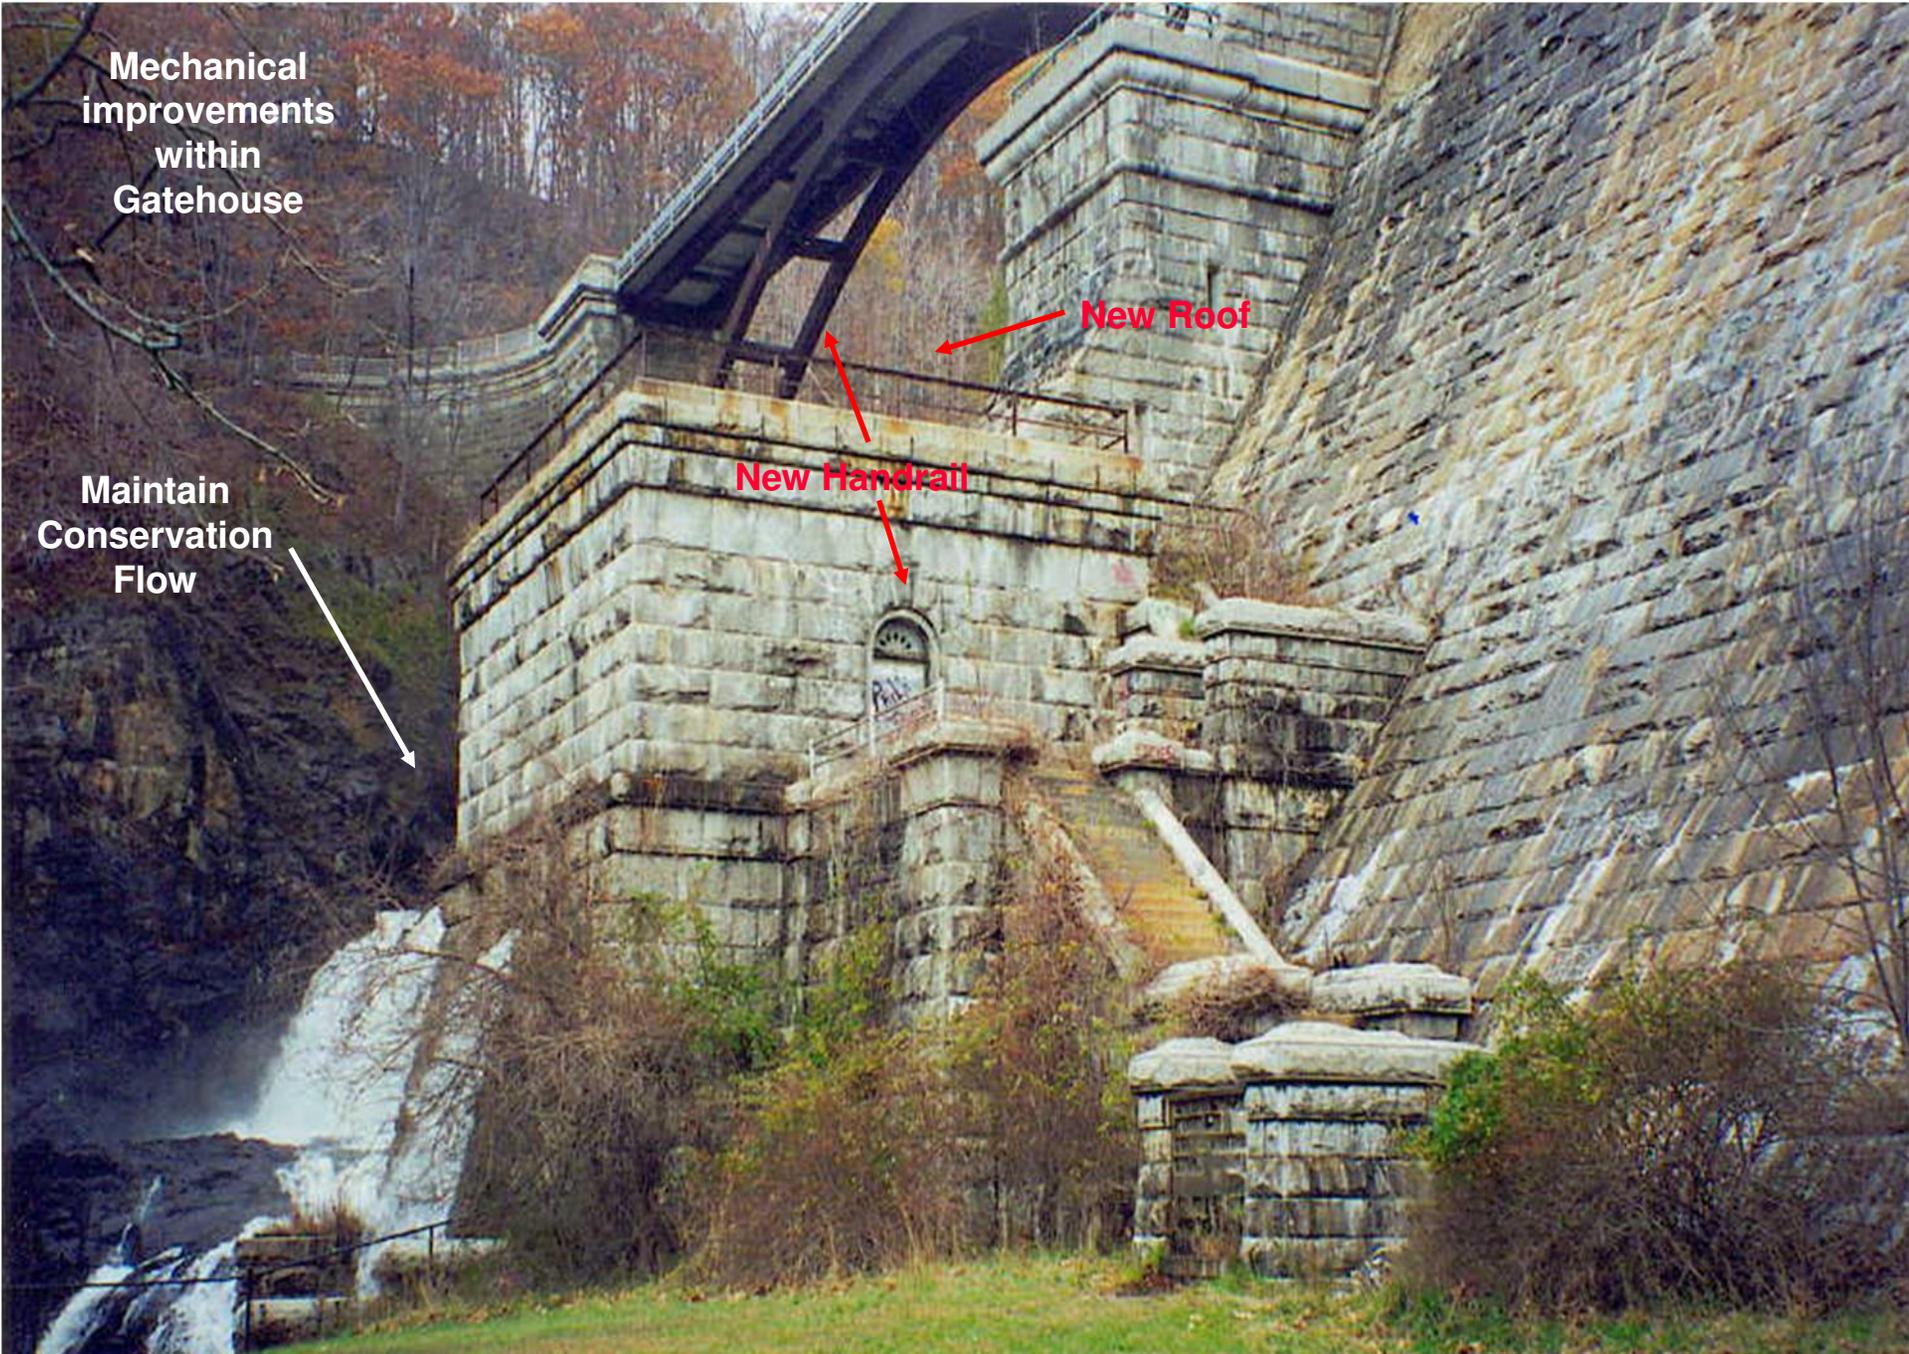
# Spillway Repairs

Mechanical improvements within Gatehouse

New Roof

New Handrail

Maintain Conservation Flow

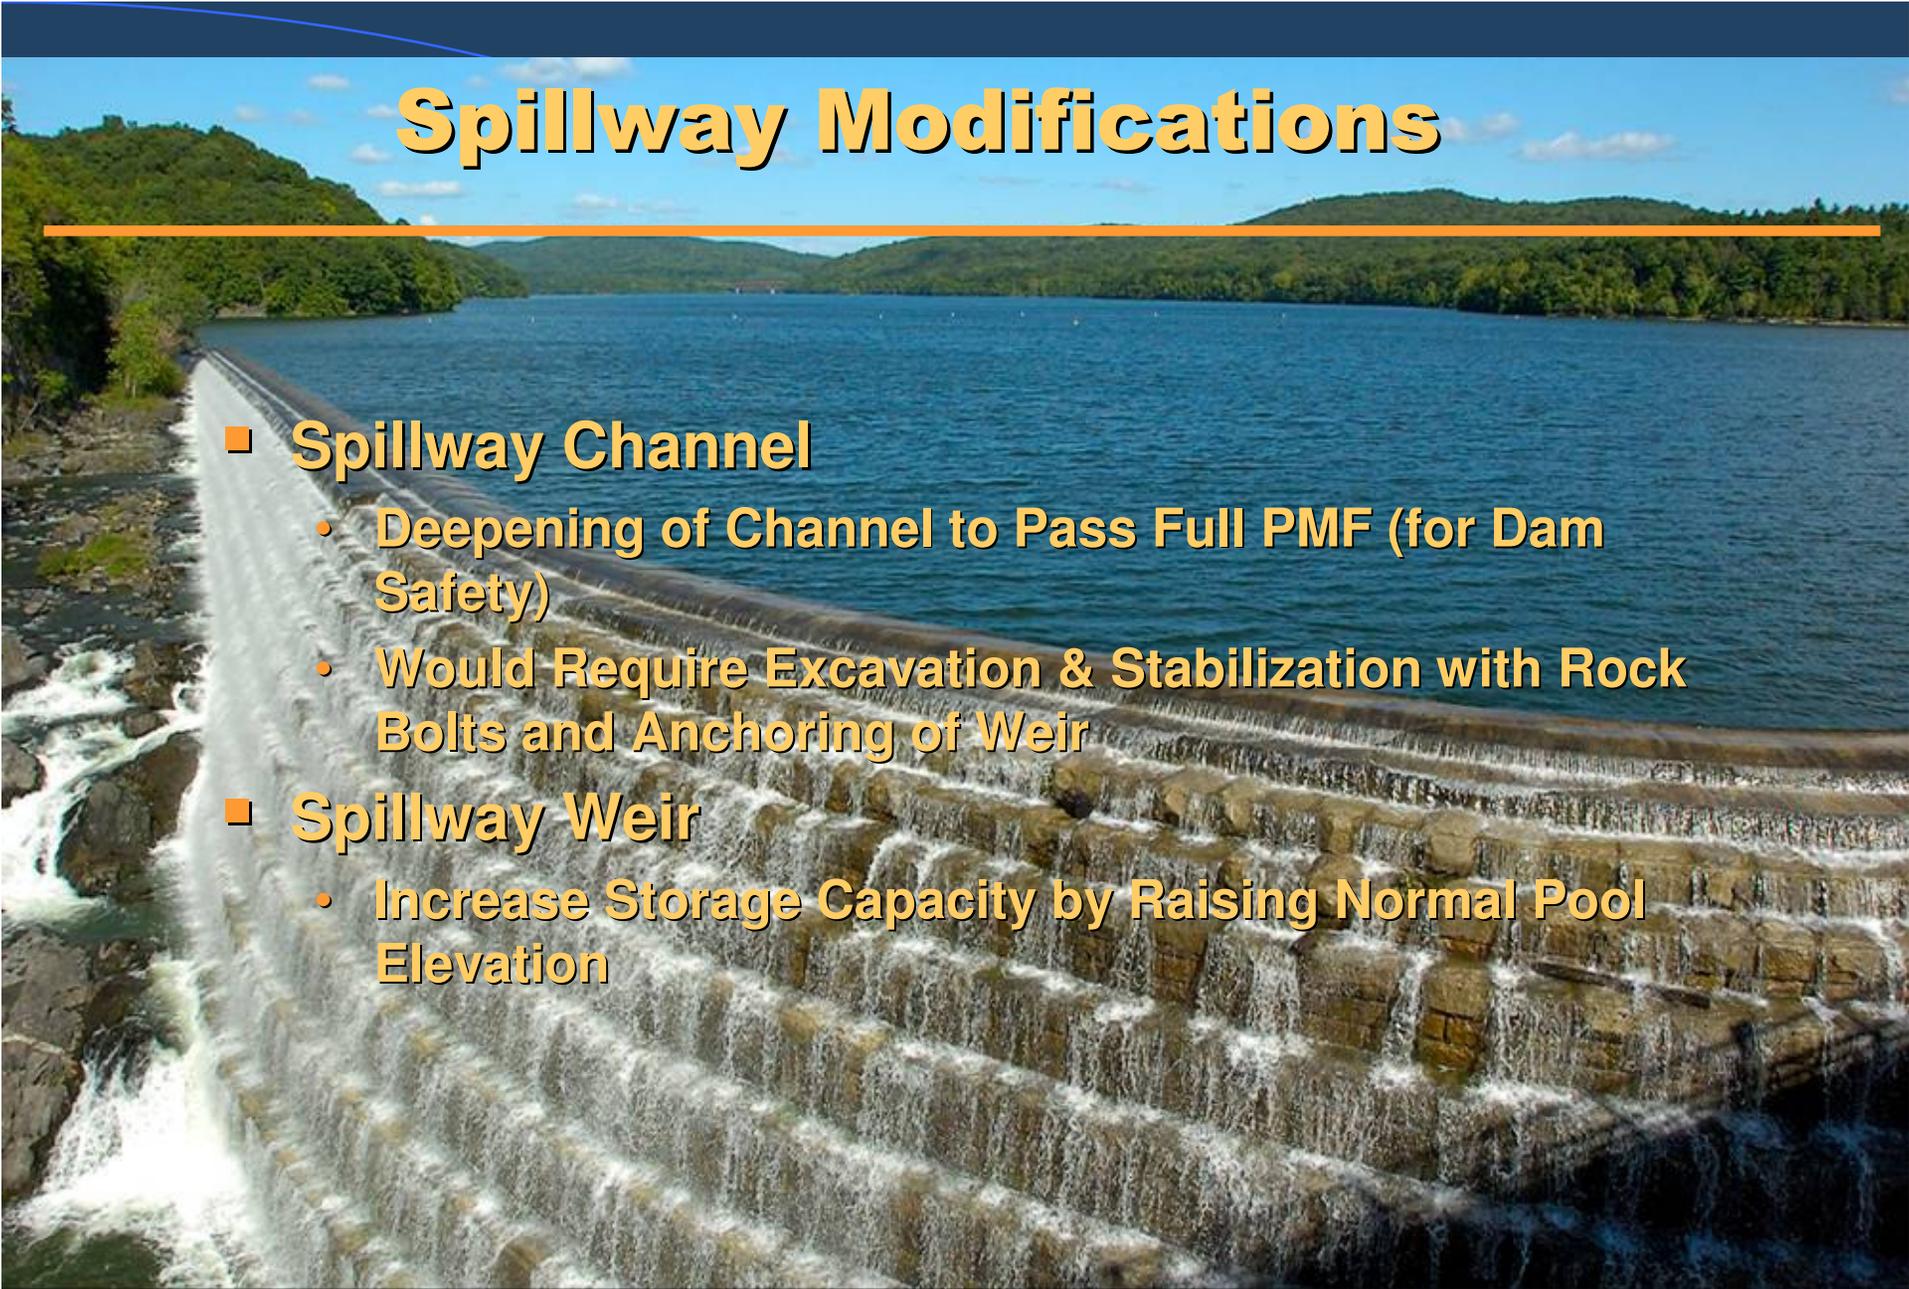
# Spillway Modifications

- **Spillway Channel**
  - Deepening of Channel to Pass Full PMF (for Dam Safety)
  - Would Require Excavation & Stabilization with Rock Bolts and Anchoring of Weir
- **Spillway Weir**
  - Increase Storage Capacity by Raising Normal Pool Elevation

Raise Normal Pool four feet to Elevation 199.6 feet  
by increasing the height of the Spillway Weir

Requires Additional Modifications to Spillway Weir by either  
Changing the Crest Shape and/or Lengthening the Weir

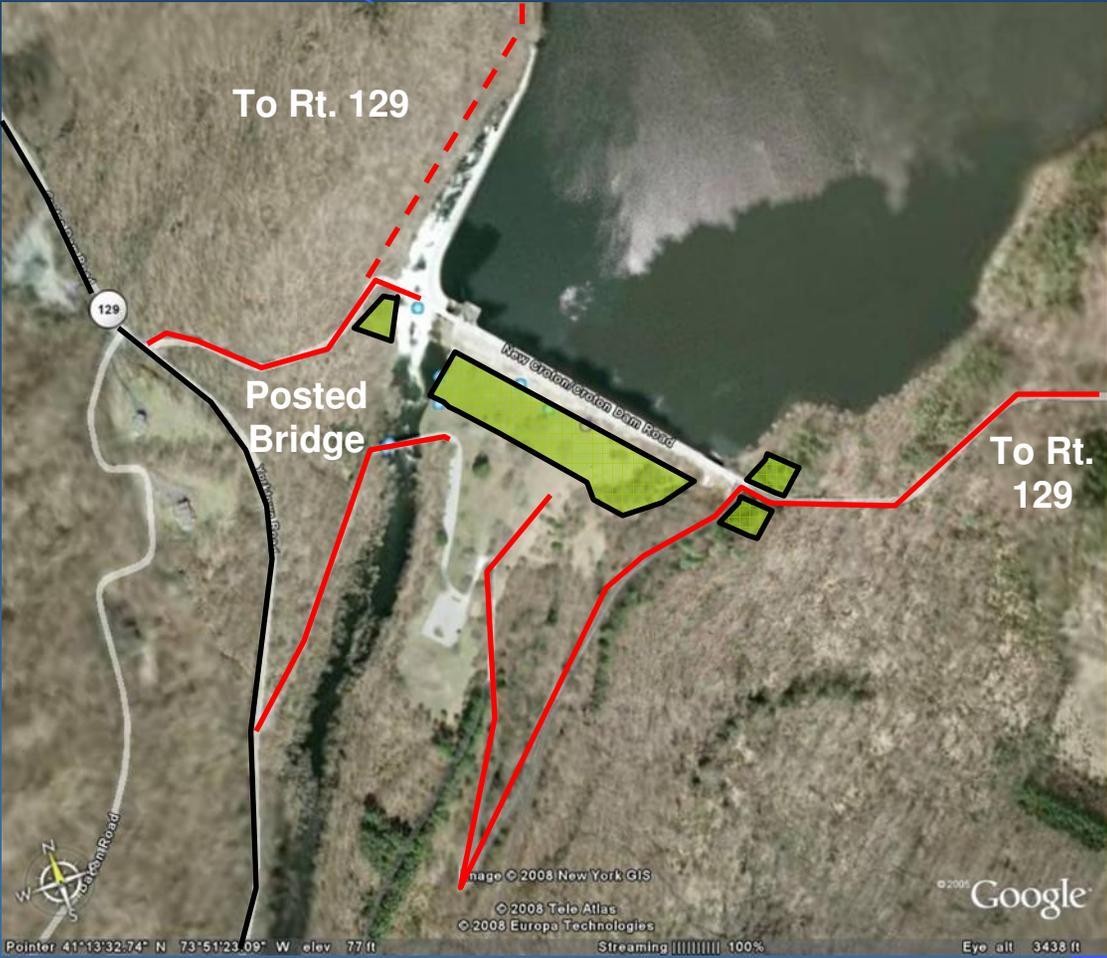
# Construction Access Roads and Staging Areas

- Main Road
- Potential Construction Access Road
- - - Potential Construction Access Road (Unpaved)
- ▭ Potential Laydown Area

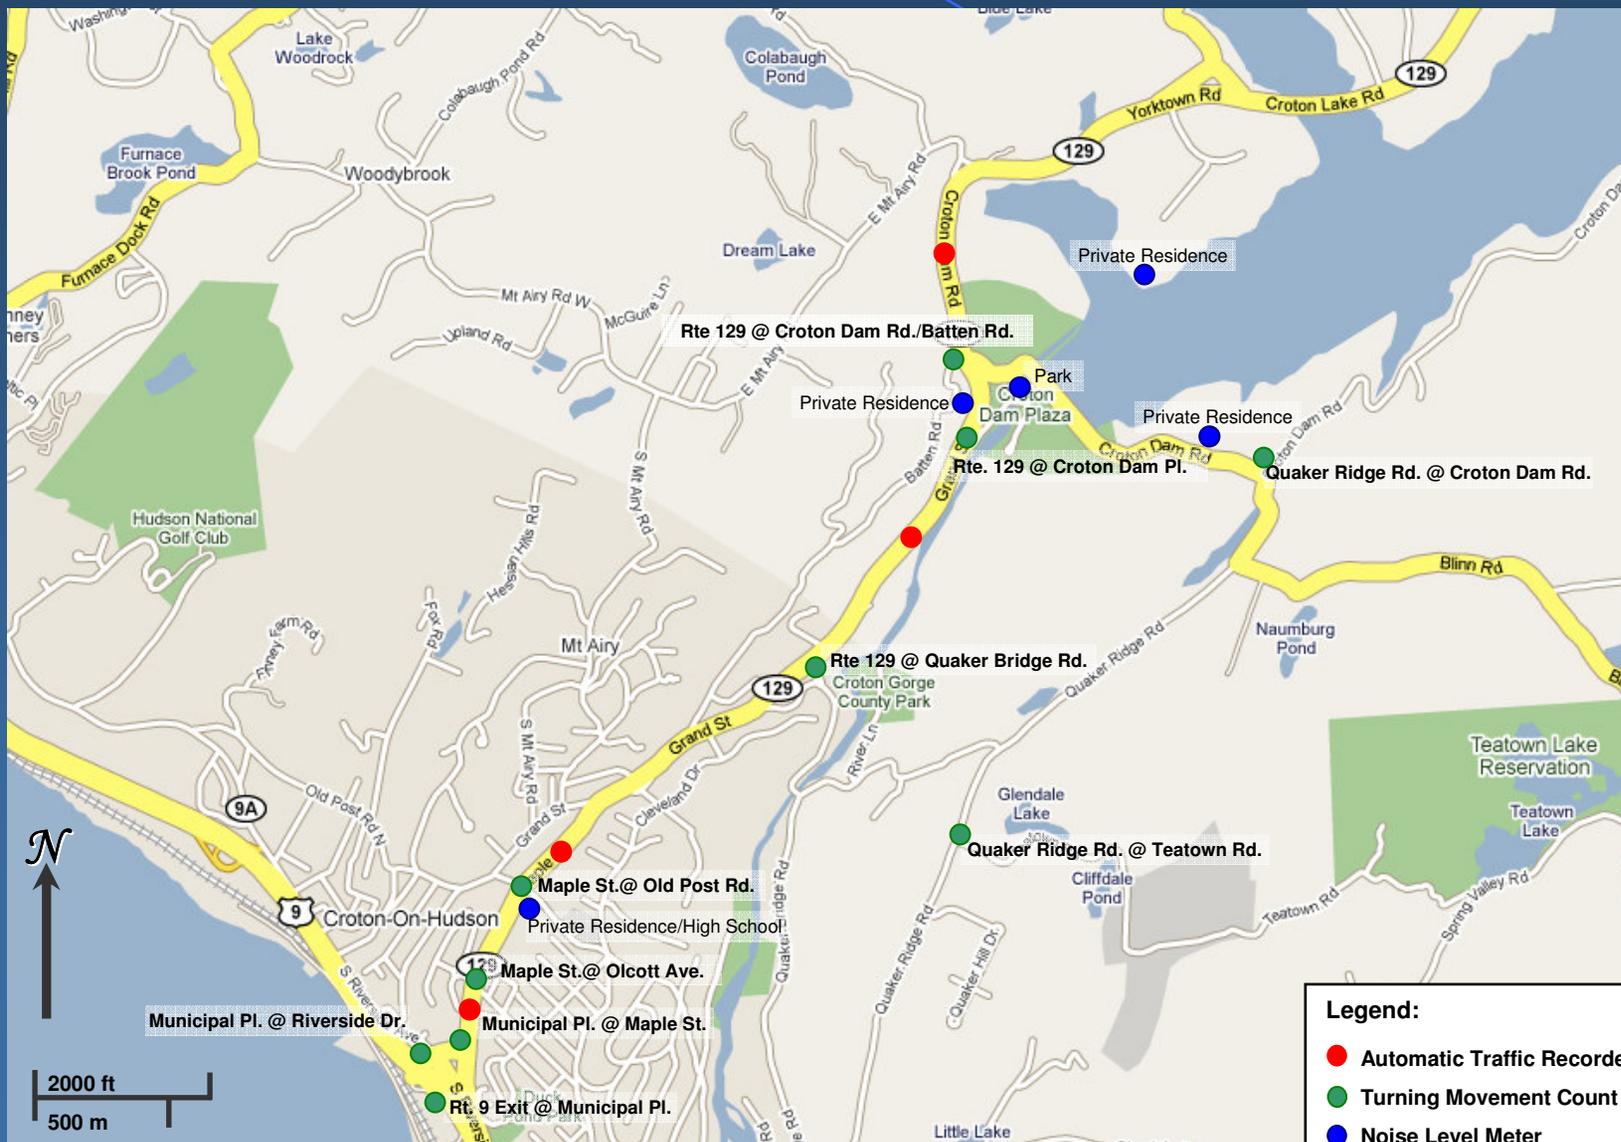
# Traffic and Noise Monitoring

# Detailed Monitoring Sites for the Village of Croton on Hudson

- Legend:**
- Automatic Traffic Recorder
  - Turning Movement Count
  - Noise Level Meter
